Manhole Inspection Summary

Manhole # S21I__028MH

Insp Date: **9/20/07 3:04 PM**

Location Address: **1947 BOOTH**

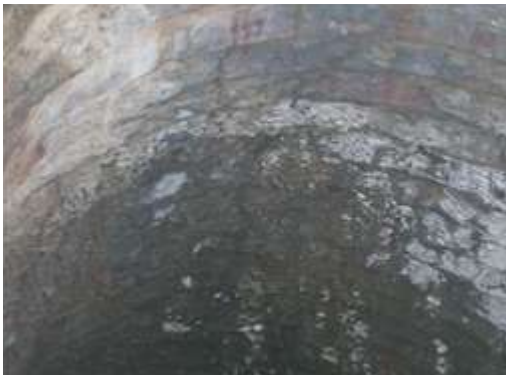
Defect 2

Offset: **2** (in.)

FRAME OFFSET

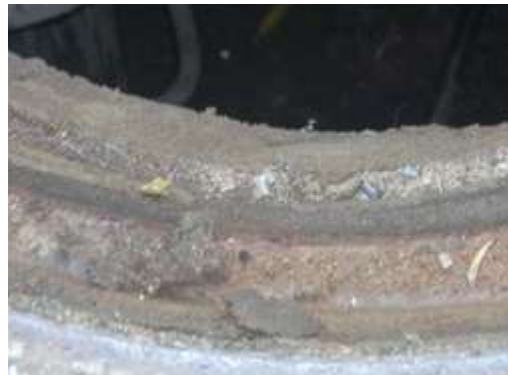
Defect 1

Infiltration: ☐ None ☐ Joint ☐ Cracks ☐ Mortar ☐ Roots ☒ Wall

CORBEL WALL INFILTRATION

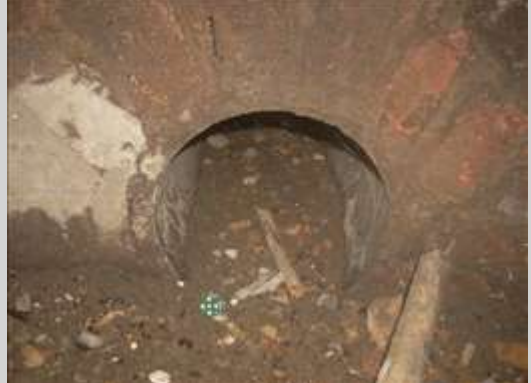
12 O'Clock Outflow

8 in. Circular Gravity Sewer
Pipe Out @ 12 O'Clock

Deposits: ☐ None ☐ Mud ☐ Sludge ☒ **Debris** ☐ Grease

Silt Depth: **1** (in.) Deposits Extent: **Light**
